**CHRISTIAN
BAUER

CORROSION BEHAVIOUR OF DISC SPRINGS

This article describes the results from a research proposal conducted as AVIF Project Number A 210, 'Investigations of the corrosion behaviour of disc springs and disc spring stacks', advised by the Spring Association (VDFI), Subcommittee on Disc Springs, via the Technical University of Darmstadt, Institute for Materials.

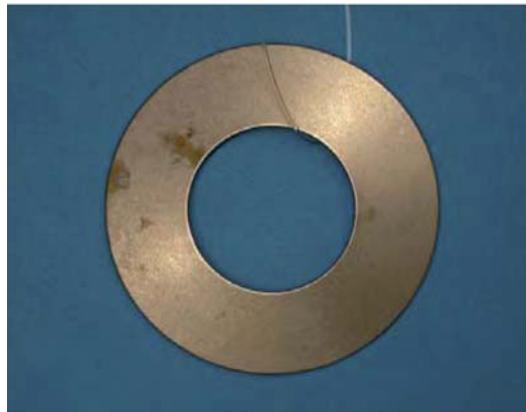
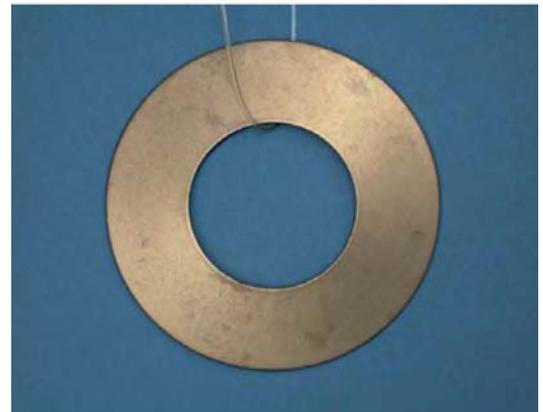
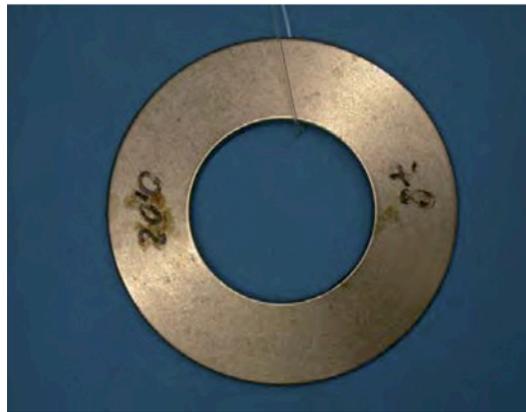
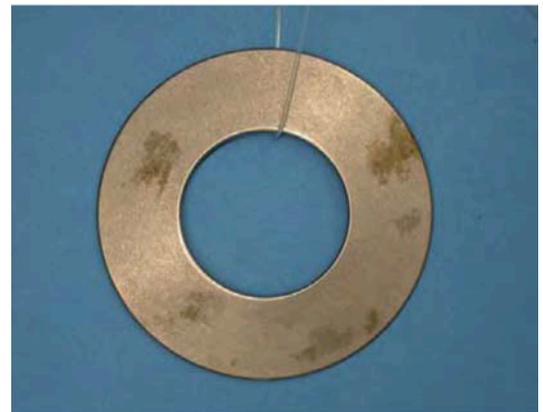
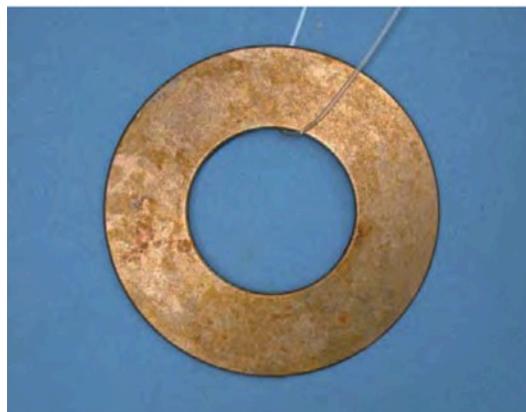
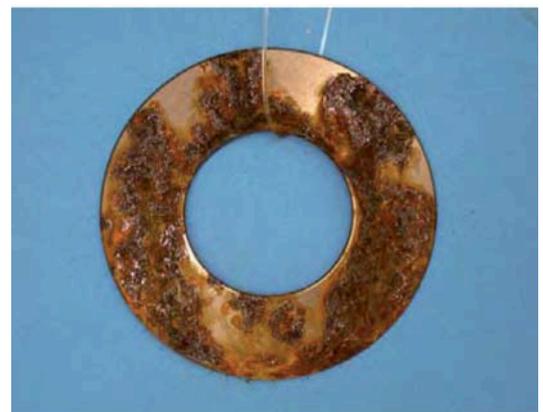
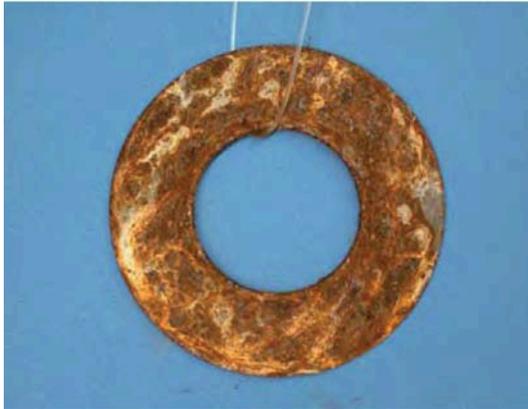
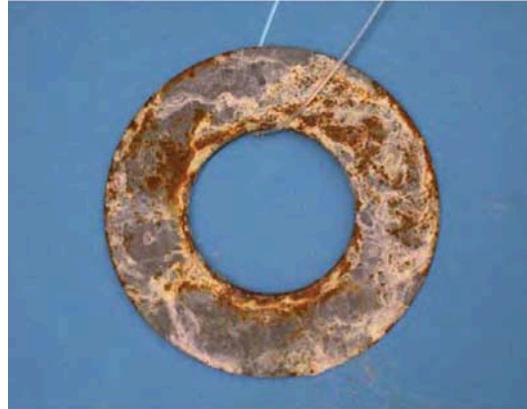
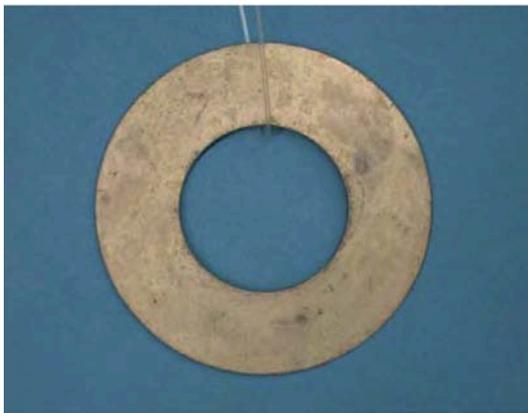
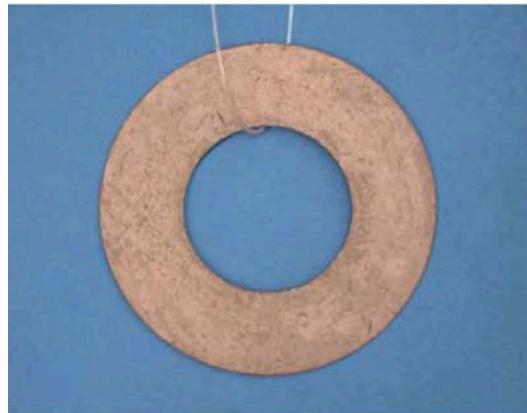
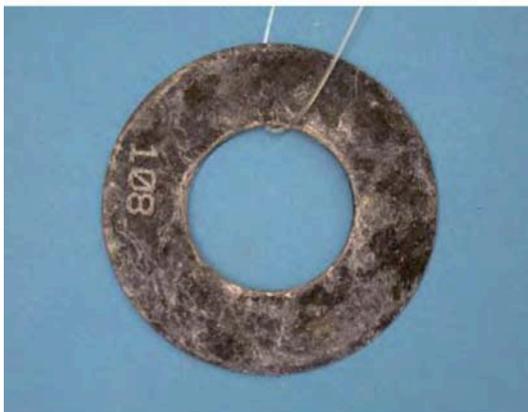
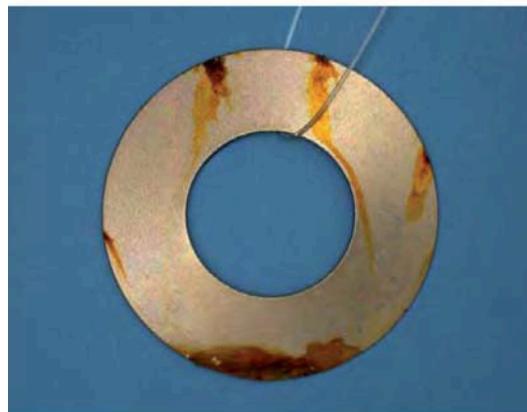
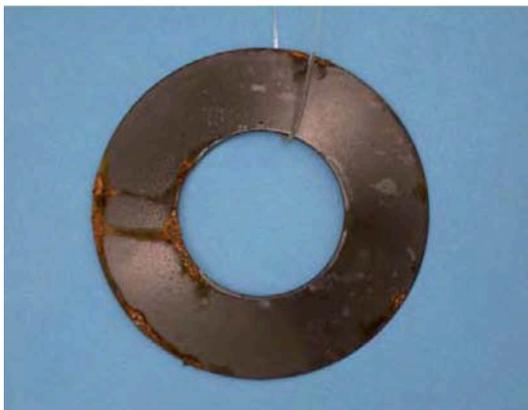
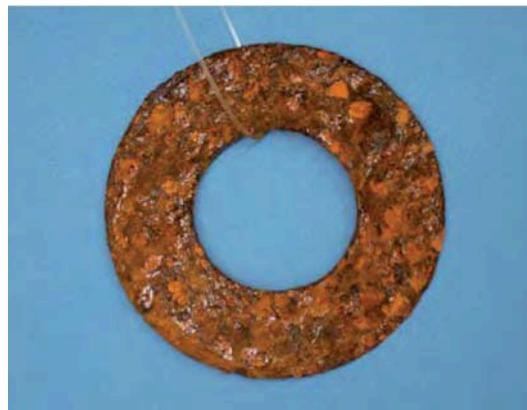
Figure 3:
Visual manifestation of corrosion on the disc springs after 4 cycles of the VDA test

Fig. 3 shows all 14 tested disc spring variants after 4 VDA alternation test cycles. No corrosion can be seen in the shot-peened disc spring composed of 1.4310; on the other two variants, a low number of brownish spots can be found, similar to the non-shot-peened disc spring variant compo-

sed of 1.4568. The shot-peened variant composed of 1.4568 behaves somewhat worse, but the difference is very low. Thus, after the four-week regular experimental time span, these five variants were left for a further 9 weeks in the salt spray chamber. The Kolsterised variant composed of 1.4568 displays the worst resistance to corrosion among the disc spring variants composed of the various stainless steels. The spring is almost fully covered with a large number of deep rust-brown spots.

The Dacromet- and Geomet-coated steel disc springs do not corrode like the shot-peened disc spring composed of 1.4310. The Delta Tone + Delta Seal coated disc spring was attacked by the corrosion medium, forming a large number of white spots, meaning that the base material of 1.8158 did not corrode. The mechanically zinc-plated disc spring variants behave even worse. The yellow chromatised variant was covered with a large number of deep rust-brown spots, and the transparent chromatised variant by a small number of rust-brown spots and a large number of white spots. The problem with blemishes in the coating on the edges appears in the chemically nickel-plated and the spring with water-thinnable paint. A moderate number of rust-brown spots indicate that the base material has corroded. The disc spring variant that has only been oiled behaves the worst and displays heavy surface corrosion.

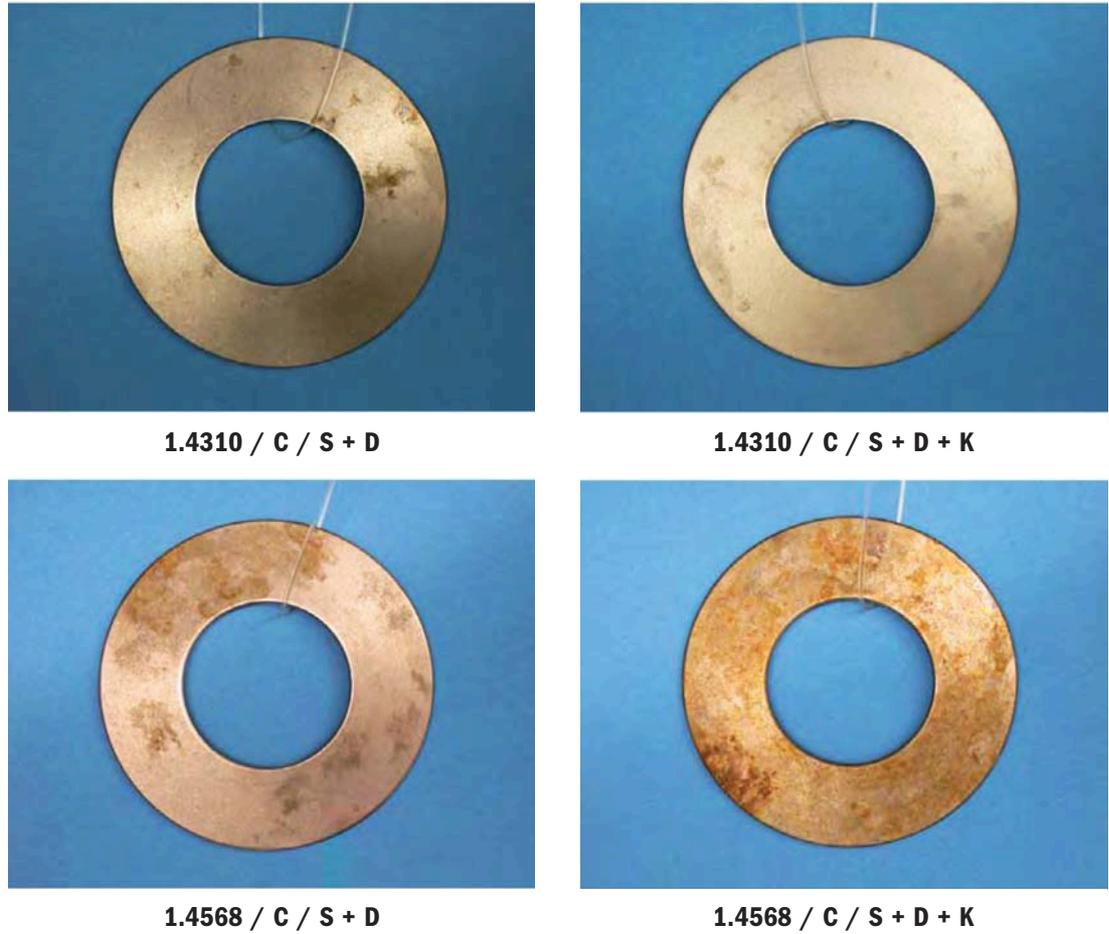
Figure 4:
Visual manifestation of corrosion on the disc springs after 13 cycles of the VDA test

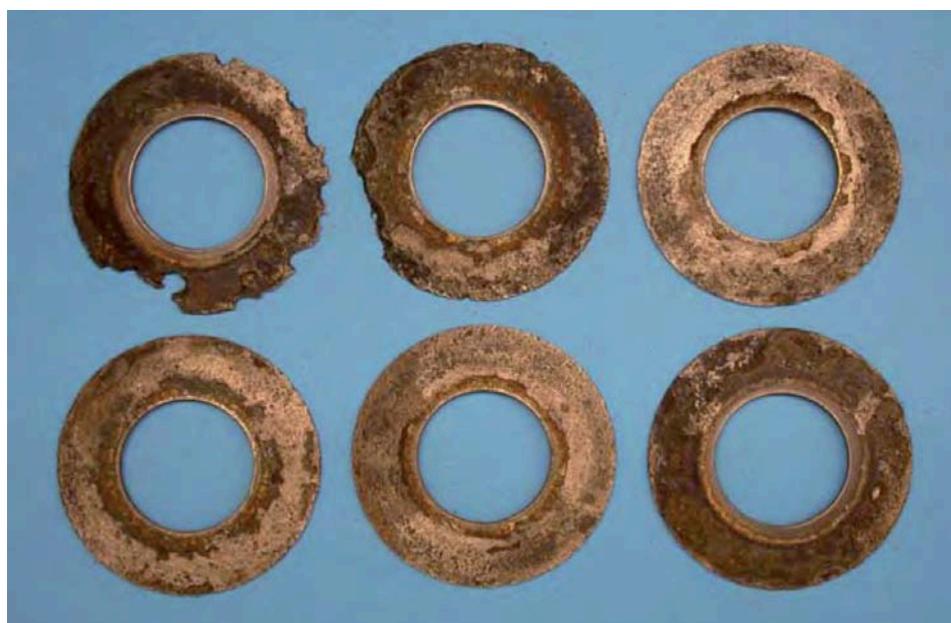
corrosive stress. However, the chemically nickel-plated disc spring variant failed in 40 % MgCl₂ solution and in 3 % NaCl solution, as did the mechanically zinc-plated and painted variants in 0.1 M citric acid. For the chemically nickel-plated disc spring variant, it appears that the acceleration in local corrosion of the base material at weak points in the inert coating is more effective than reduction of corrosion due to the low temperature. The coatings for the mechanically zinc-plated and painted disc springs also react very strongly with the citric acid.

Figure 7: Condition of the mechanically zinc-plated and transparently chromatised disc springs after over 2500 h under 0.2h₀ stress in citric acid

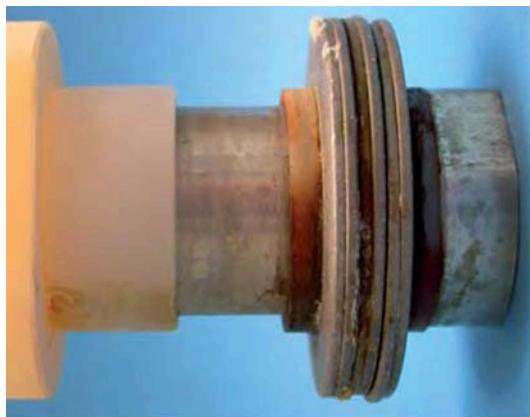
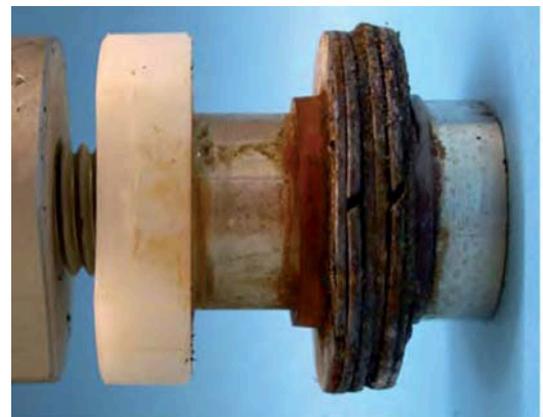
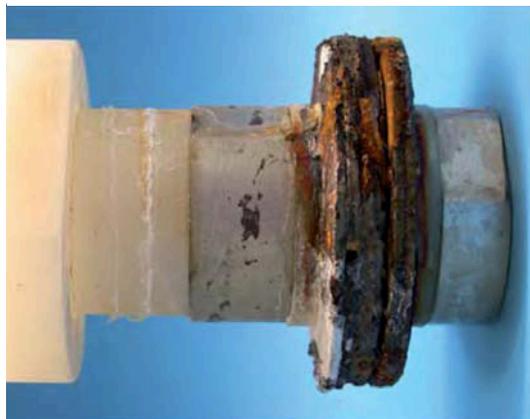
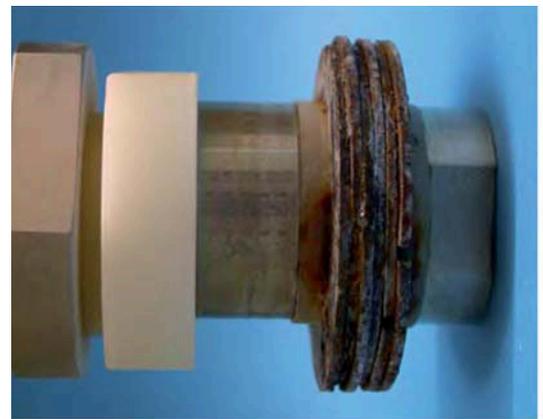
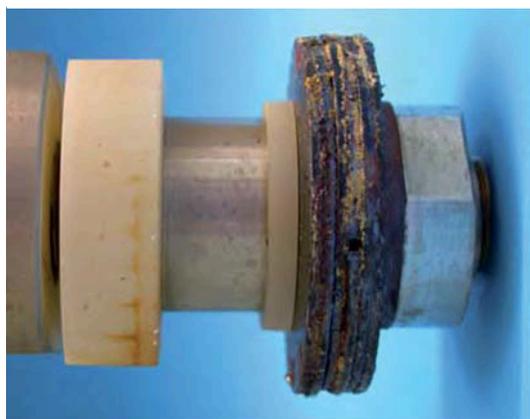
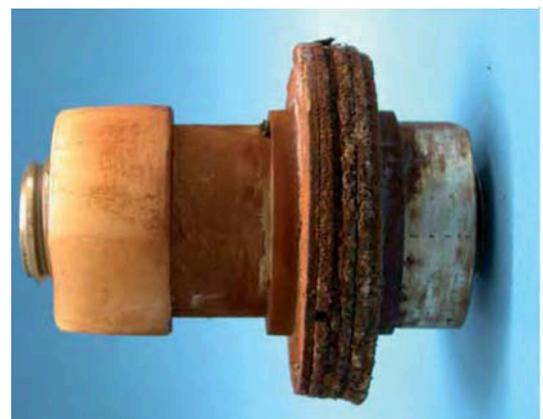
The Dacromet- and Geomet-coated springs looked as new after 2500 h. These two coatings bestow optimal protection on the slightly alloyed basic material in the seawater atmosphere. The mechanically zinc-plated disc spring is covered with a foamy rust-brown corrosion product layer. Due to the low chloride concentration in the atmosphere, no Simonkolleite (Zn₅(OH)₈Cl₂·H₂O) layer forms; rather, loose and voluminous coatings are generated on the surface. These have no defined composition; rather, they consist of a variety of products. In addition, the effectiveness of chromate layers decreases at temperatures over 60°C.

The Delta Tone/Delta Seal-coated spring is in a significantly worse condition than the Geomet-coated spring, but better than the mechanically zinc-plated spring. Only in the problem zone, the edge region, are there some rust-brown dots. The variant with the water-dilutable lacquer and the chemically nickel-plated variant display the same problem of a locally permeable coating. The oiled-only disc spring corroded heavily. The protective oil bestows only short-term protection, and the high oxygen content in the atmosphere accelerates the corrosion.

Figure 9:
Visual manifestation of corrosion on the disc springs in the stress corrosion crack experiment in seawater atmosphere ($0.8h_0$ and $80\text{ }^\circ\text{C}$)

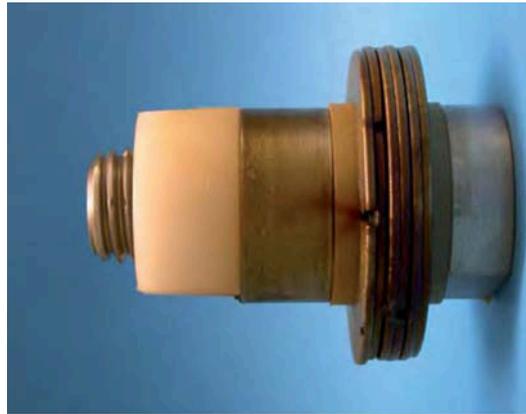
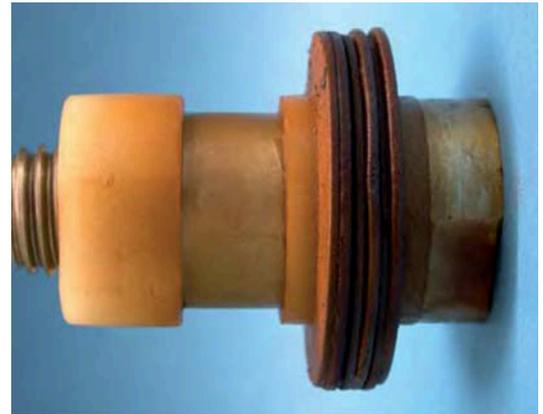
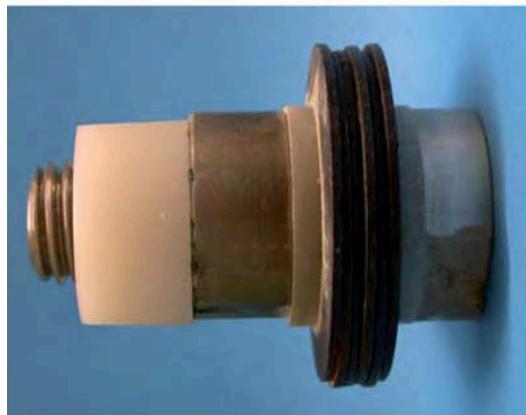
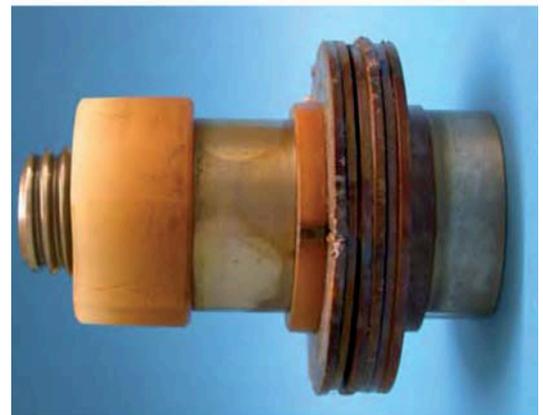
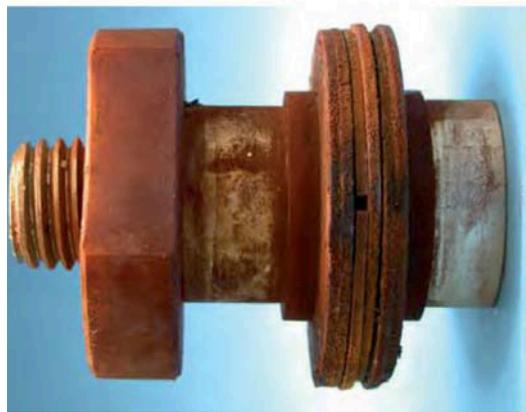
Figure 11:
Visual manifestation of corrosion on the disc springs in the stress corrosion crack experiment in 40 % $MgCl_2$ solution ($0.8h_0$ and 80 °C)

The notches created by pitting lead, however, to a local elevation of tensile stress. If no intermediate repassivation is possible, the attack will continue

to grow deeper, and the crack will propagate at an increasing rate. In media containing chloride, the mechanism of crack formation is accompanied by pitting which then can grow sharply even if the crack only progresses slowly. The variants depicted in Figure 12 are thus produced according to the rate of crack propagation.

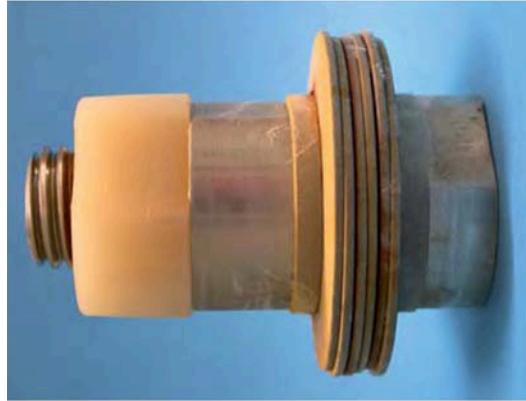
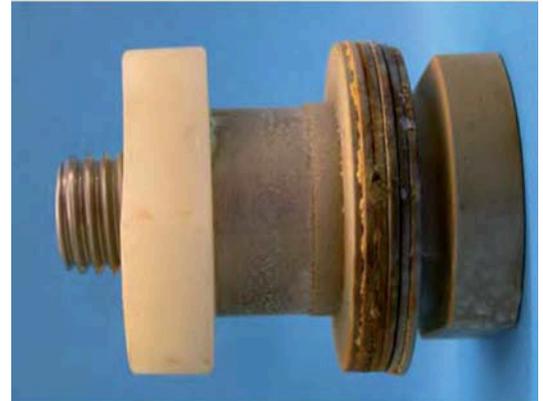
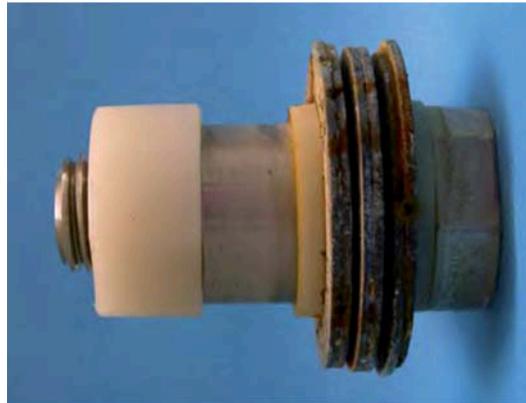
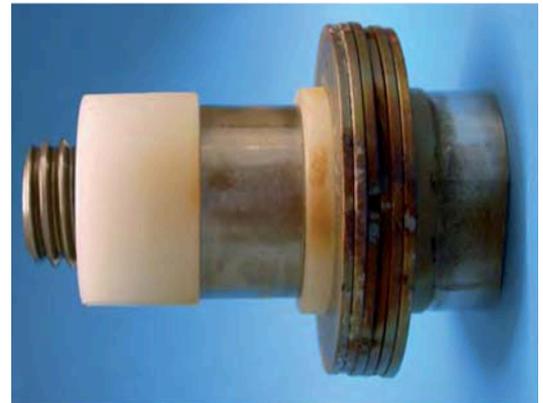
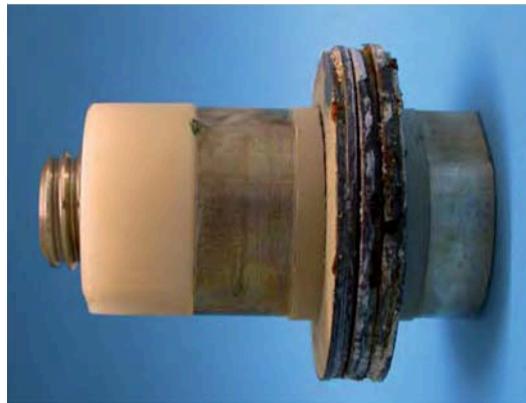
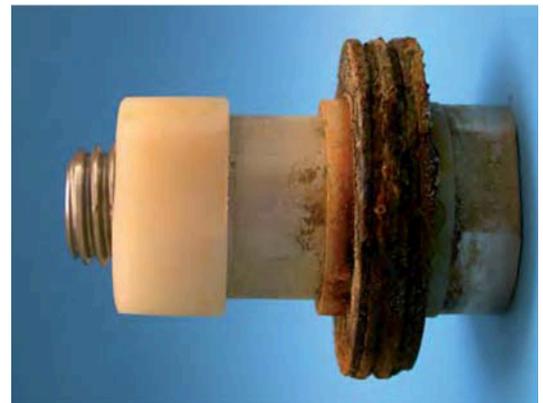
Figure 14:
Visual manifestation
of corrosion on the
disc springs in the
stress corrosion crack
experiment in 3 %
MgCl₂ solution (0.8h₀
and 80 °C)

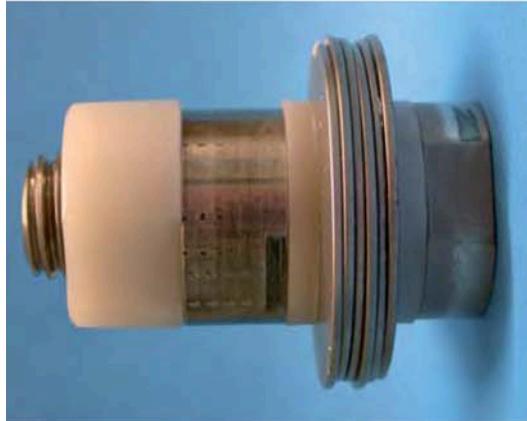
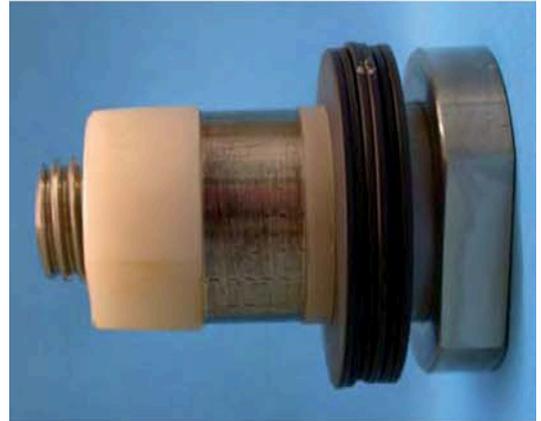
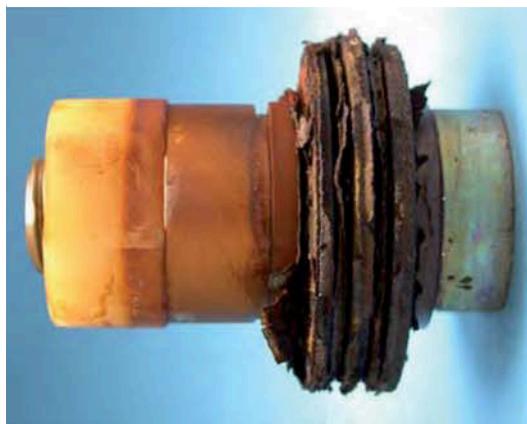
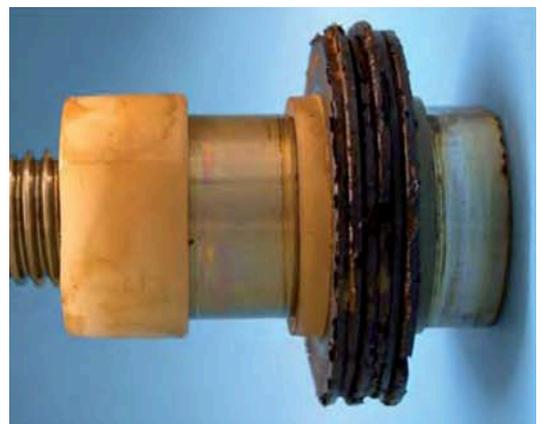
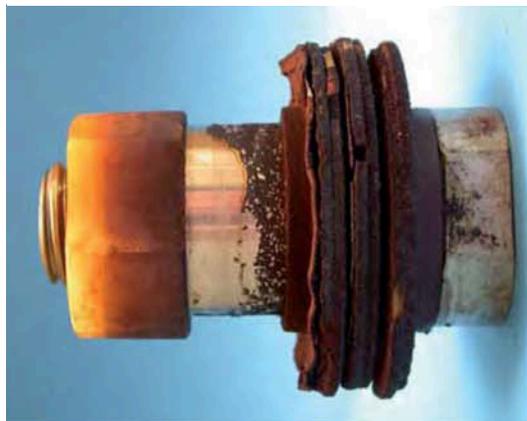
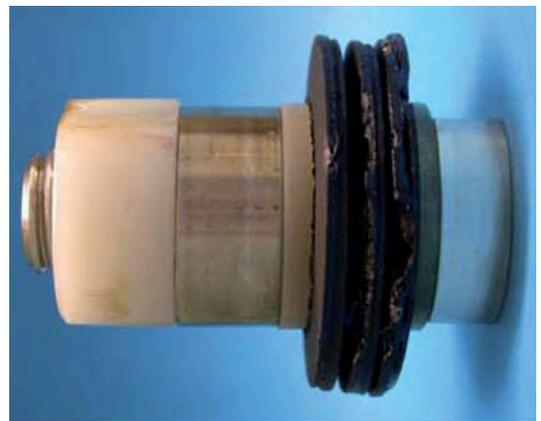
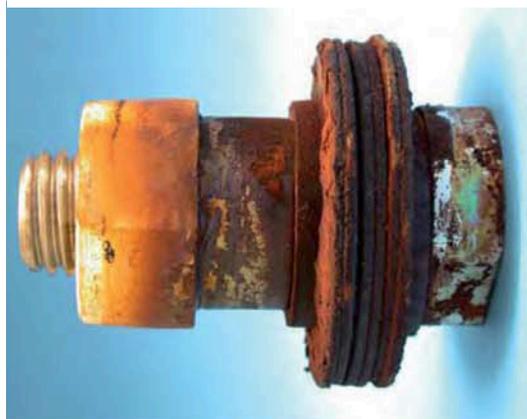
Figure 16:
Visual manifestation
of corrosion on the
disc springs in the
stress corrosion crack
experiment in 0.1 M
citric acid ($0.8h_0$ and
80 °C)

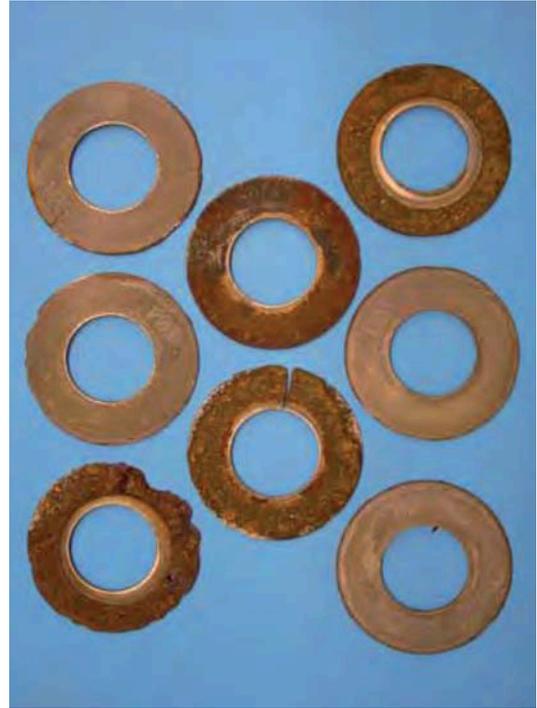
Figure 18: Visual manifestation of corrosion on the mechanically zinc-plated disc springs in citric acid

Through the parallel layering of disc springs in the 4 x 2 disc spring stack, additional friction is generated between the conical surfaces, which delays the propagation of the cracks. Moreover, for the 4 x 2 disc spring stack, unlike for the 6 x 1 layering, some surfaces are not in contact with the corrosion medium (see Figures 17 and 18).

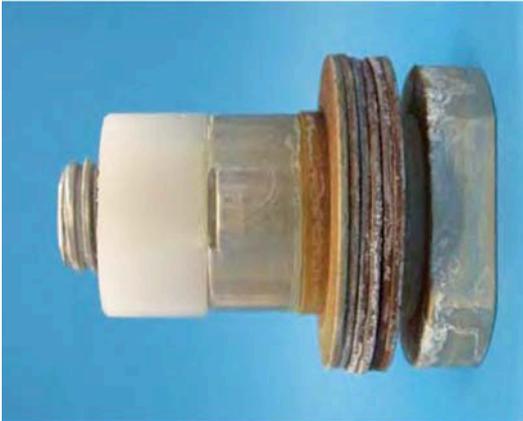
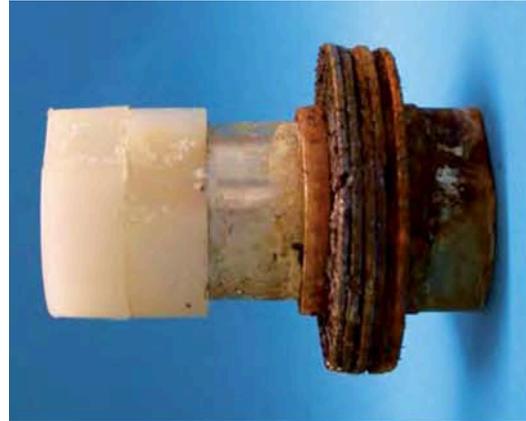
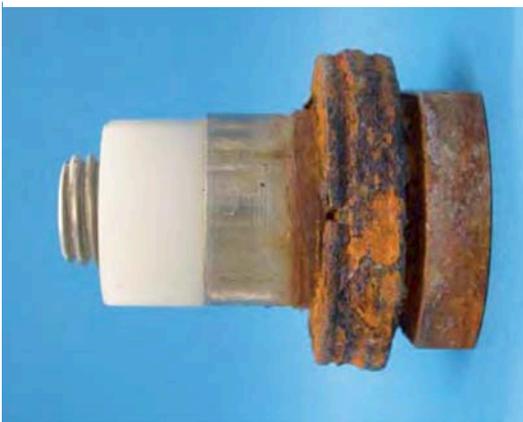
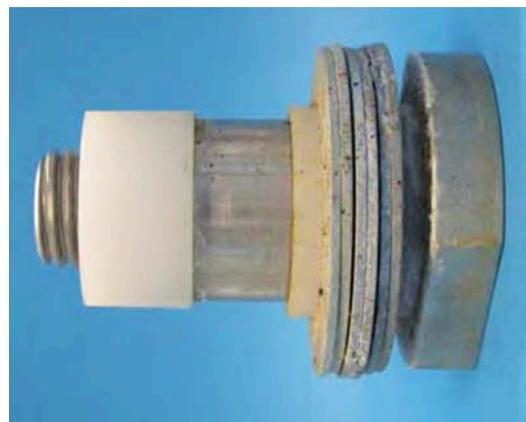
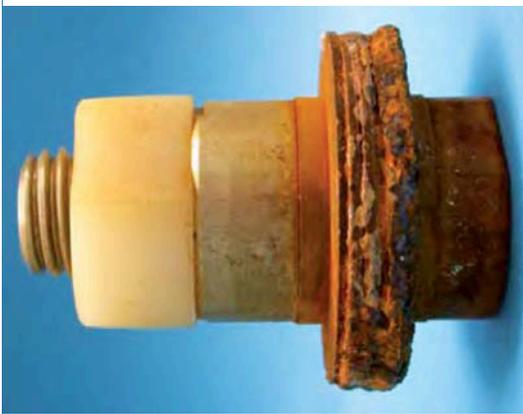
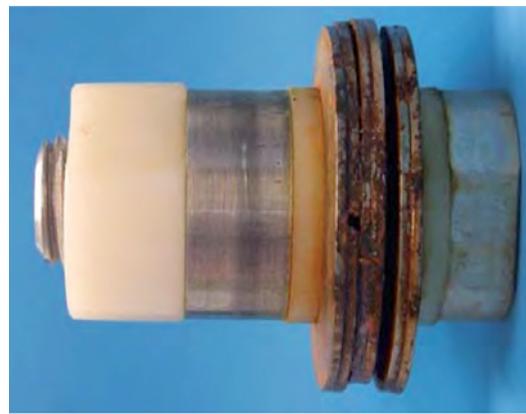
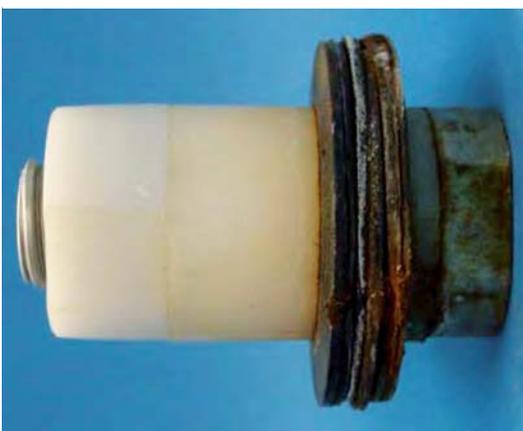
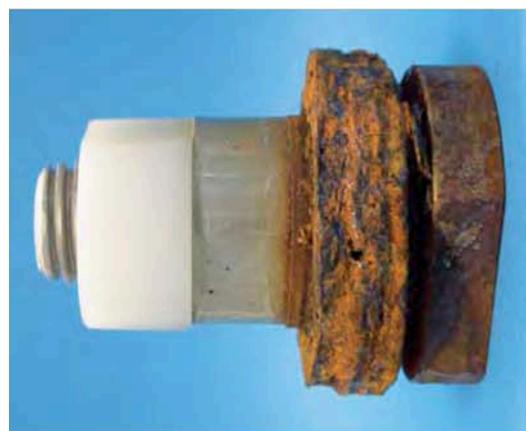
Since the experimental temperature for the VDA alternation test is significantly lower than 80 °C, the lifespan in the VDA alternation test is longer than for the stress corrosion crack experiments in seawater atmosphere at 80 °C, but shorter than at 40 °C. All results are shown in Table 15. For stainless steels, only the Kolsterised variant failed. As in the VDA alternation test, the yellow chromatised springs behave worse than the transparent chromatised springs. Even the oiled and chemically nickel-plated variants failed here, but with decreasing preload the lifespan increases significantly. Permeable sites in the coating lead to point corrosion at the edges of the chemically nickel-plated and painted disc springs.

Figure 20:
Visual manifestation
of corrosion on the
disc springs after the
VDA alternation test
with mechanical load

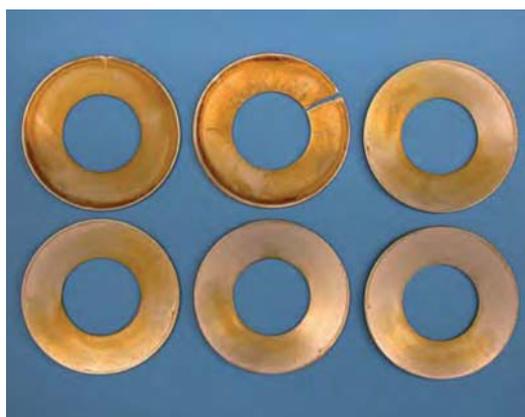
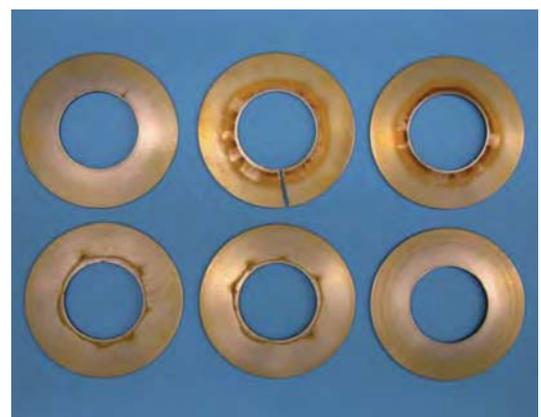
Figure 26: Visual manifestations of corrosion on non-shot-peened disc springs composed of 1.4310 after the fatigue crack corrosion experiment in 3 % NaCl solution
